8 March 2010 Elazığ-Kovancılar (Turkey) Earthquake: Observations on Ground Motions and Building Damage

Sinan Akkar,¹ Alper Aldemir,¹ Aysegul Askan,^{1,2} Sadık Bakır,¹ Erdem Canbay,¹ İ. Ozan Demirel,¹ M. Altug Erberik,¹ Zeynep Gülerce,¹ Polat Gülkan,¹ Erol Kalkan,³ Surya Prakash,⁴ M. Abdullah Sandıkkaya,¹ Volkan Sevilgen,³ Beliz Ugurhan,¹ and Emrah Yenier¹

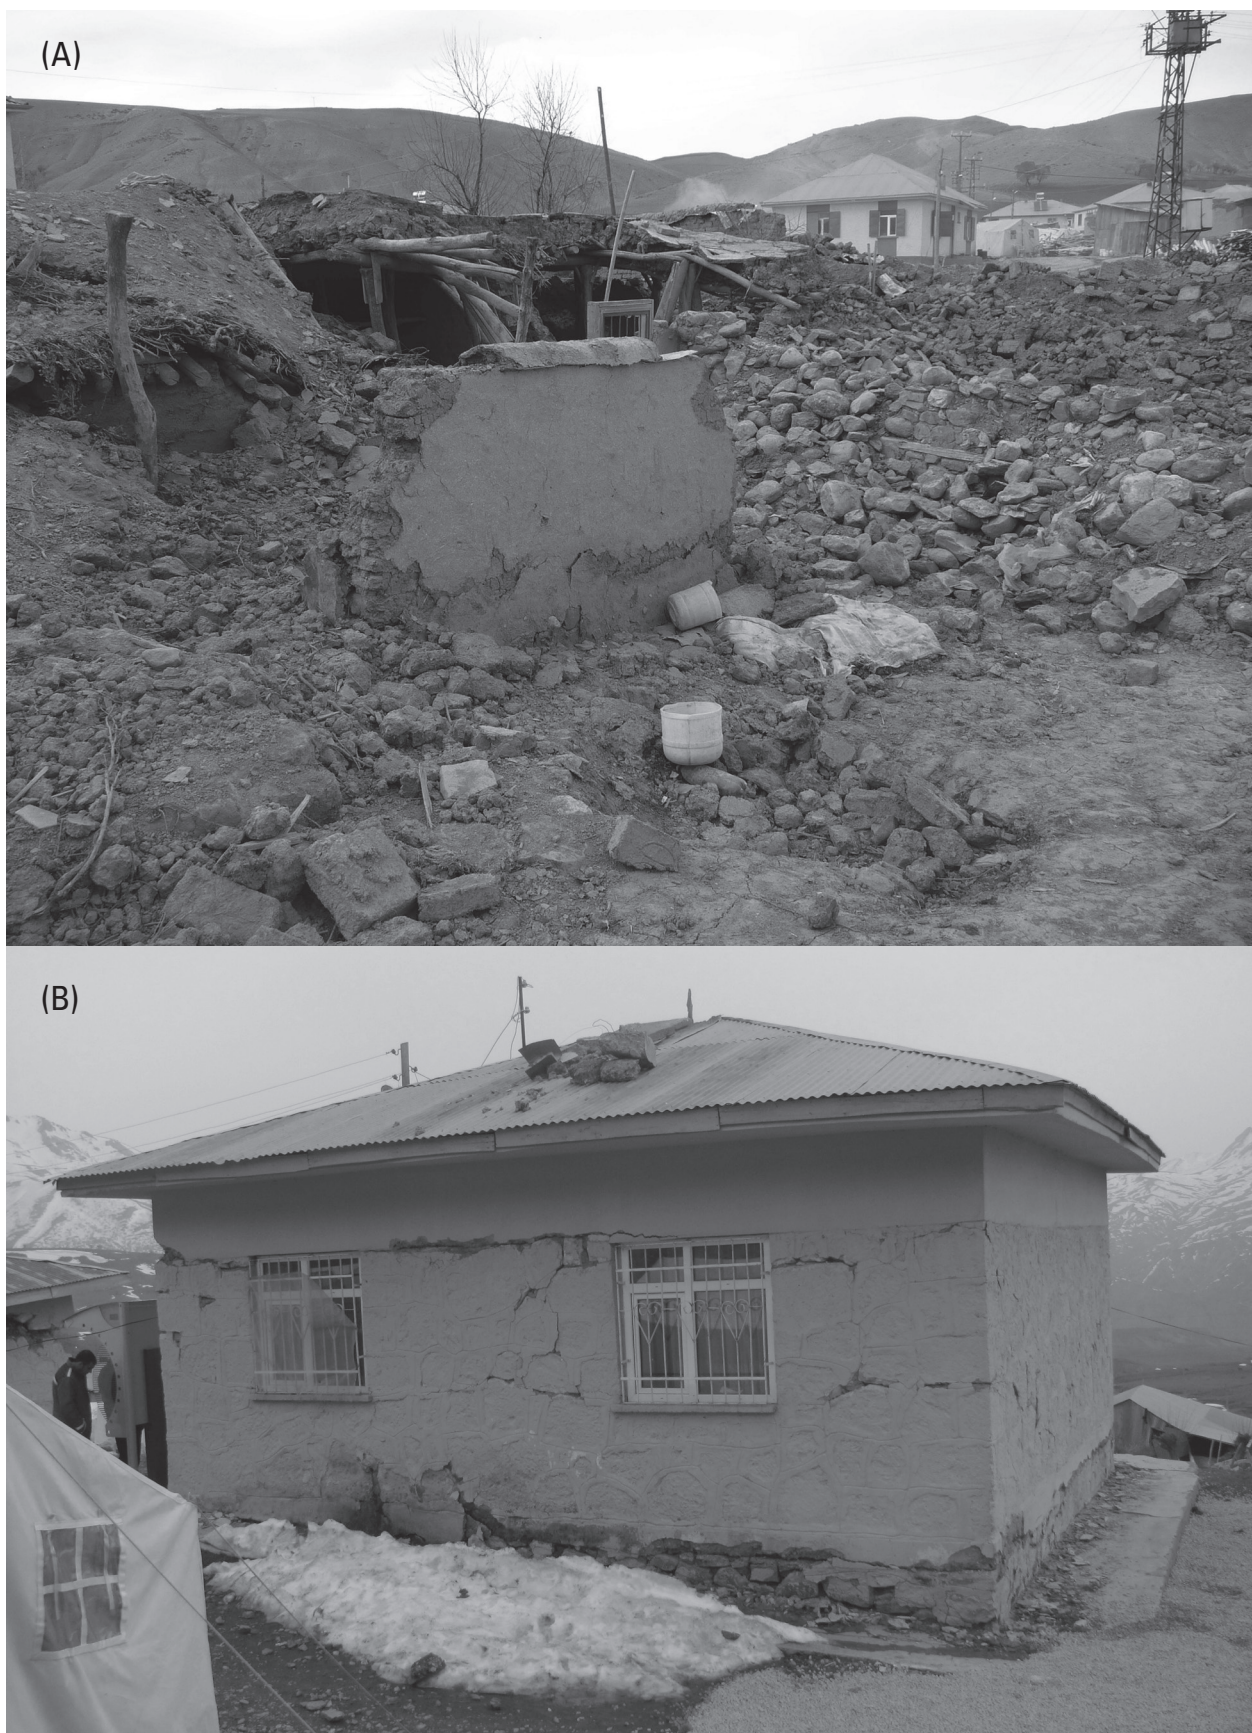
Type I buildings constitute the most vulnerable structural system. Many such buildings have collapsed in past earthquakes resulting in the loss of lives. The thickness of the condensed soil at the roof is between 30 and 50 cm. Such heavy roofs induce large inertial forces during earthquakes, which result in high stresses on low-strength walls. Roof cave-in becomes a death trap for the people inside the building (Figure 7A). We assign EMS vulnerability class A to this type of building.

horizontal bond beams, relatively better corner connections, and better vertical alignment of openings. This type of building is not earthquake resistant but can withstand earthquakes of moderate intensity since some basic rules of thumb have been considered during construction. Therefore, the buildings in this category experienced some damage during the Elazığ Kovancılar earthquake, but total collapse was usually prevented (Figure 7B). We assign EMS vulnerability class B to this type of building.

▲ **Figure 7.** Local buildings classified according to structural typology. Examples of A) Type I, B) Type II buildings (continued next page).

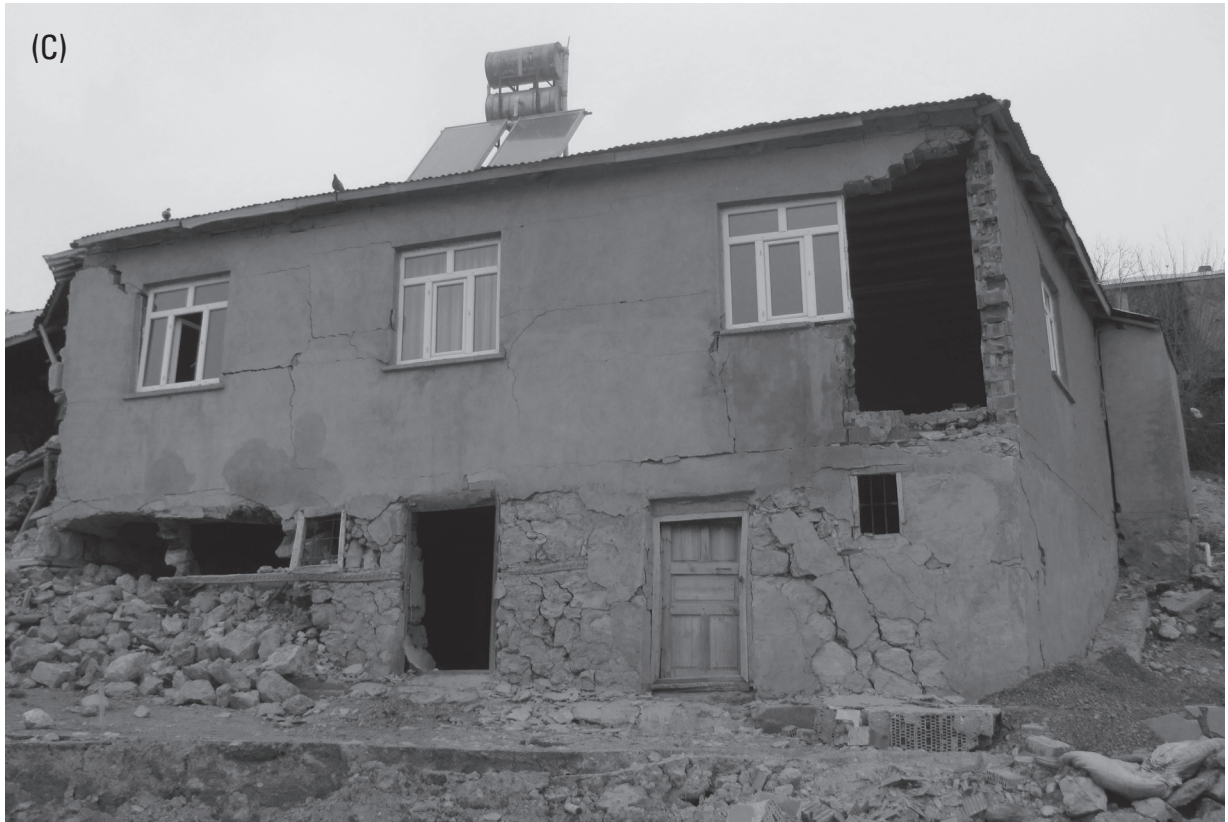
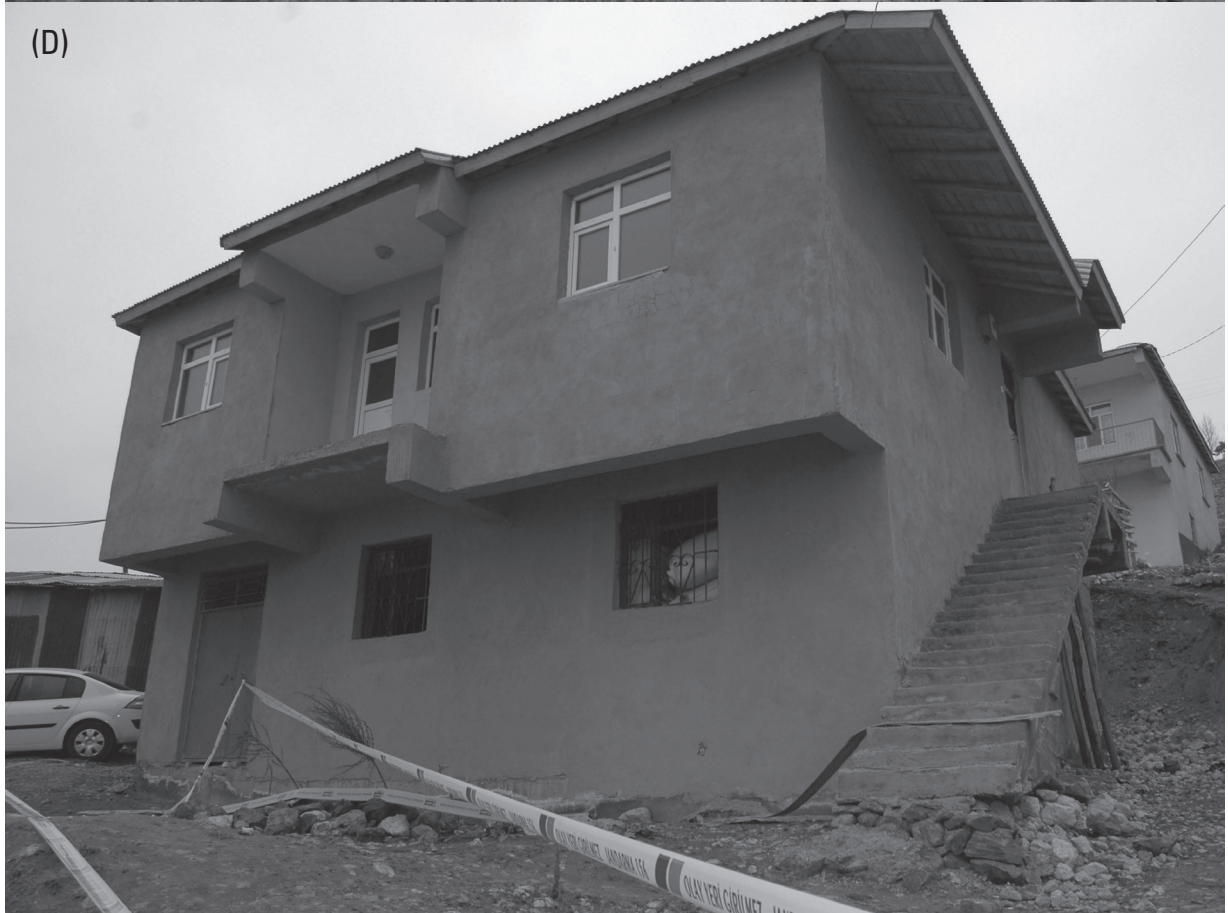
Type III buildings are frequently encountered and are the most complex structural systems in Turkish construction practices. Their ground story is often used as a barn or for storage. It is generally made of stone, but there are also cases where adobe is used. The second story is used for residential purposes and is generally made of hollow factory brick. The main problem in this type of building is the incompatibility of the materials used for different stories and their improper connection to each other. Partial out-of-plane collapse of second-story walls is a typical damage pattern for this type of building (Figure 7C). We assign EMS vulnerability class A to this type of building.

Type IV buildings are rarely observed in the field. Reinforced concrete columns, beams, and slabs are the load-bearing members. Unlike Type I, II, and III buildings, rigid diaphragm action is valid for this type of building due to the stiff concrete slab. However, the material quality is poor and construction practice does not generally conform to fundamental requirements of earthquake-resistant design. It should not be surprising that this type of building exhibited an adequate performance with limited damage during such a moderate earthquake (Figure 7D). We assign EMS vulnerability class C to this type of building.

▲ **Figure 7 (continued).** Local buildings classified according to structural typology. Examples of C) Type III, and D) Type IV buildings.

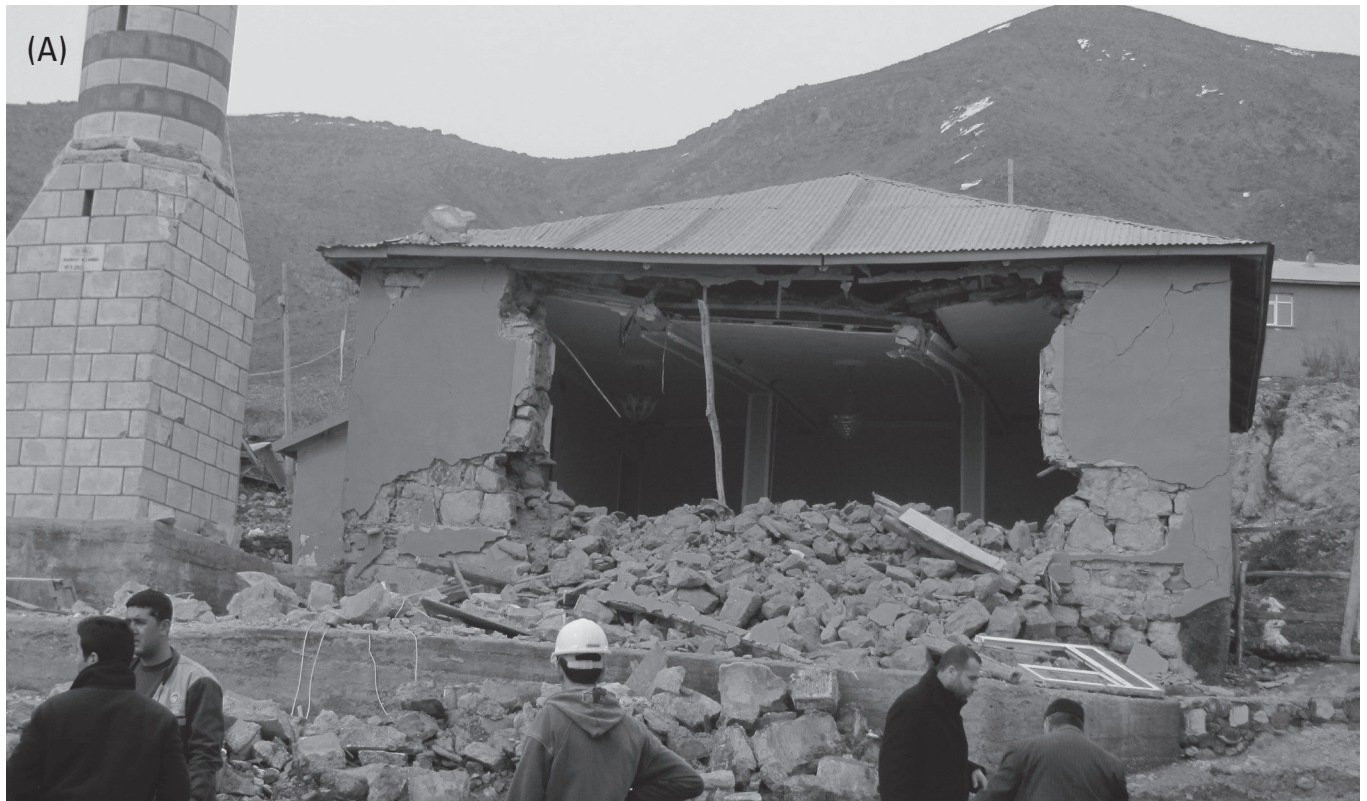
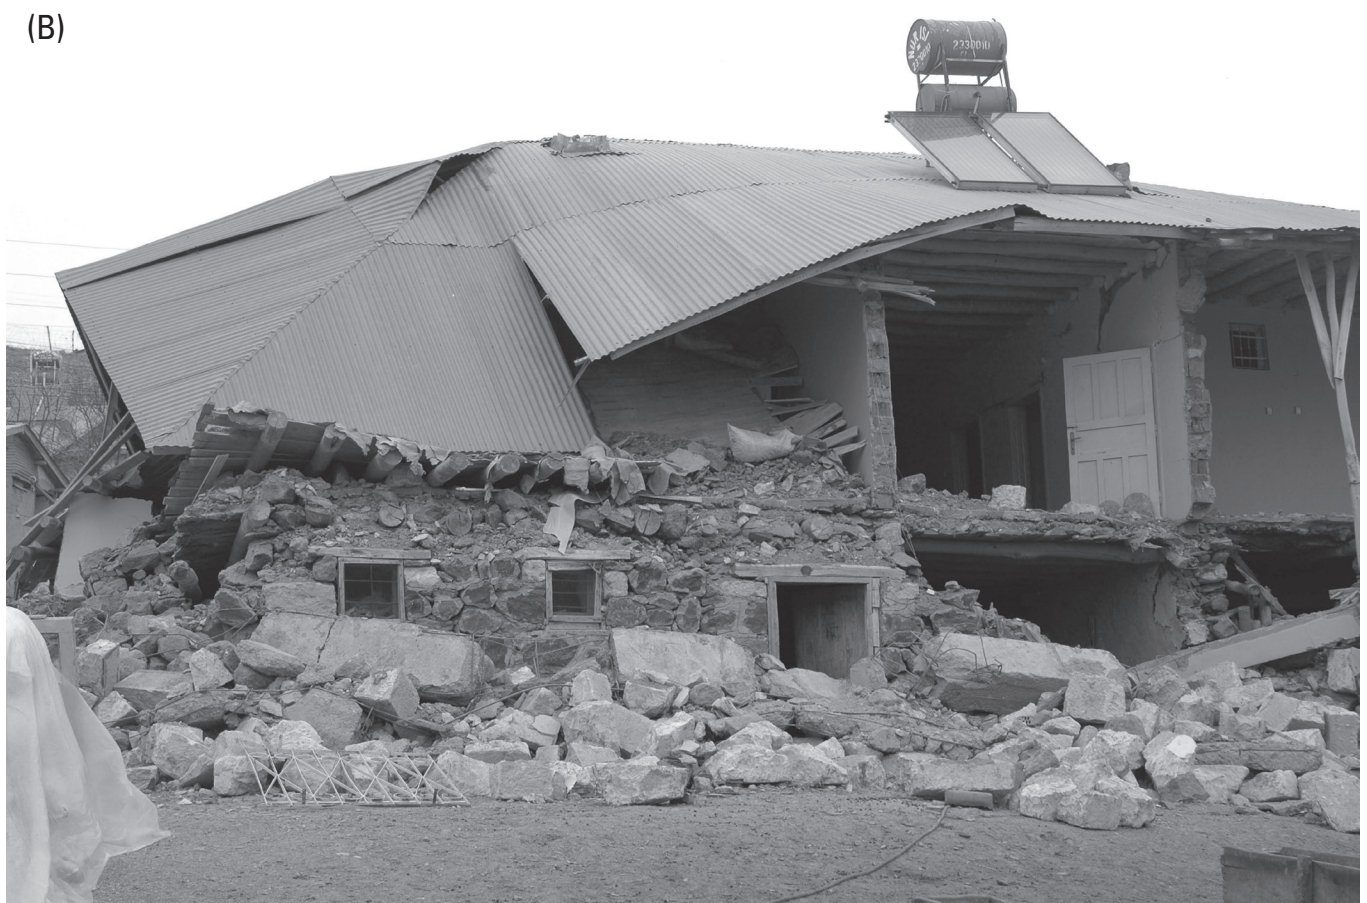
The failure modes of rural masonry buildings observed in the field are out-of-plane failure of walls and gable end walls, in-plane failure of walls, total or partial collapse of the buildings due to the absence of structural integrity, and collapse of the roof. We can see from the site observations that out-of-plane failure of walls and gable end walls are a frequent mode of failure. The main causes of this are stability problems that arise from large unsupported wall lengths in the absence of lateral supporting walls (Figure 8A), poor wall-to-floor connections

▲ **Figure 8.** Out-of-plane failures of walls due to A) large unsupported wall length, B) poor wall-to-wall connection (continued next page).

(Figure 8B), and poor wall-to-wall connections (Figure 8C). In the absence of connecting units and proper detailing at the connections of perpendicular walls, the walls are separated from each other and behave like single walls that are weak in the out-of-plane direction. We also observed the collapse of gable end walls during the field investigations (Figure 8D).

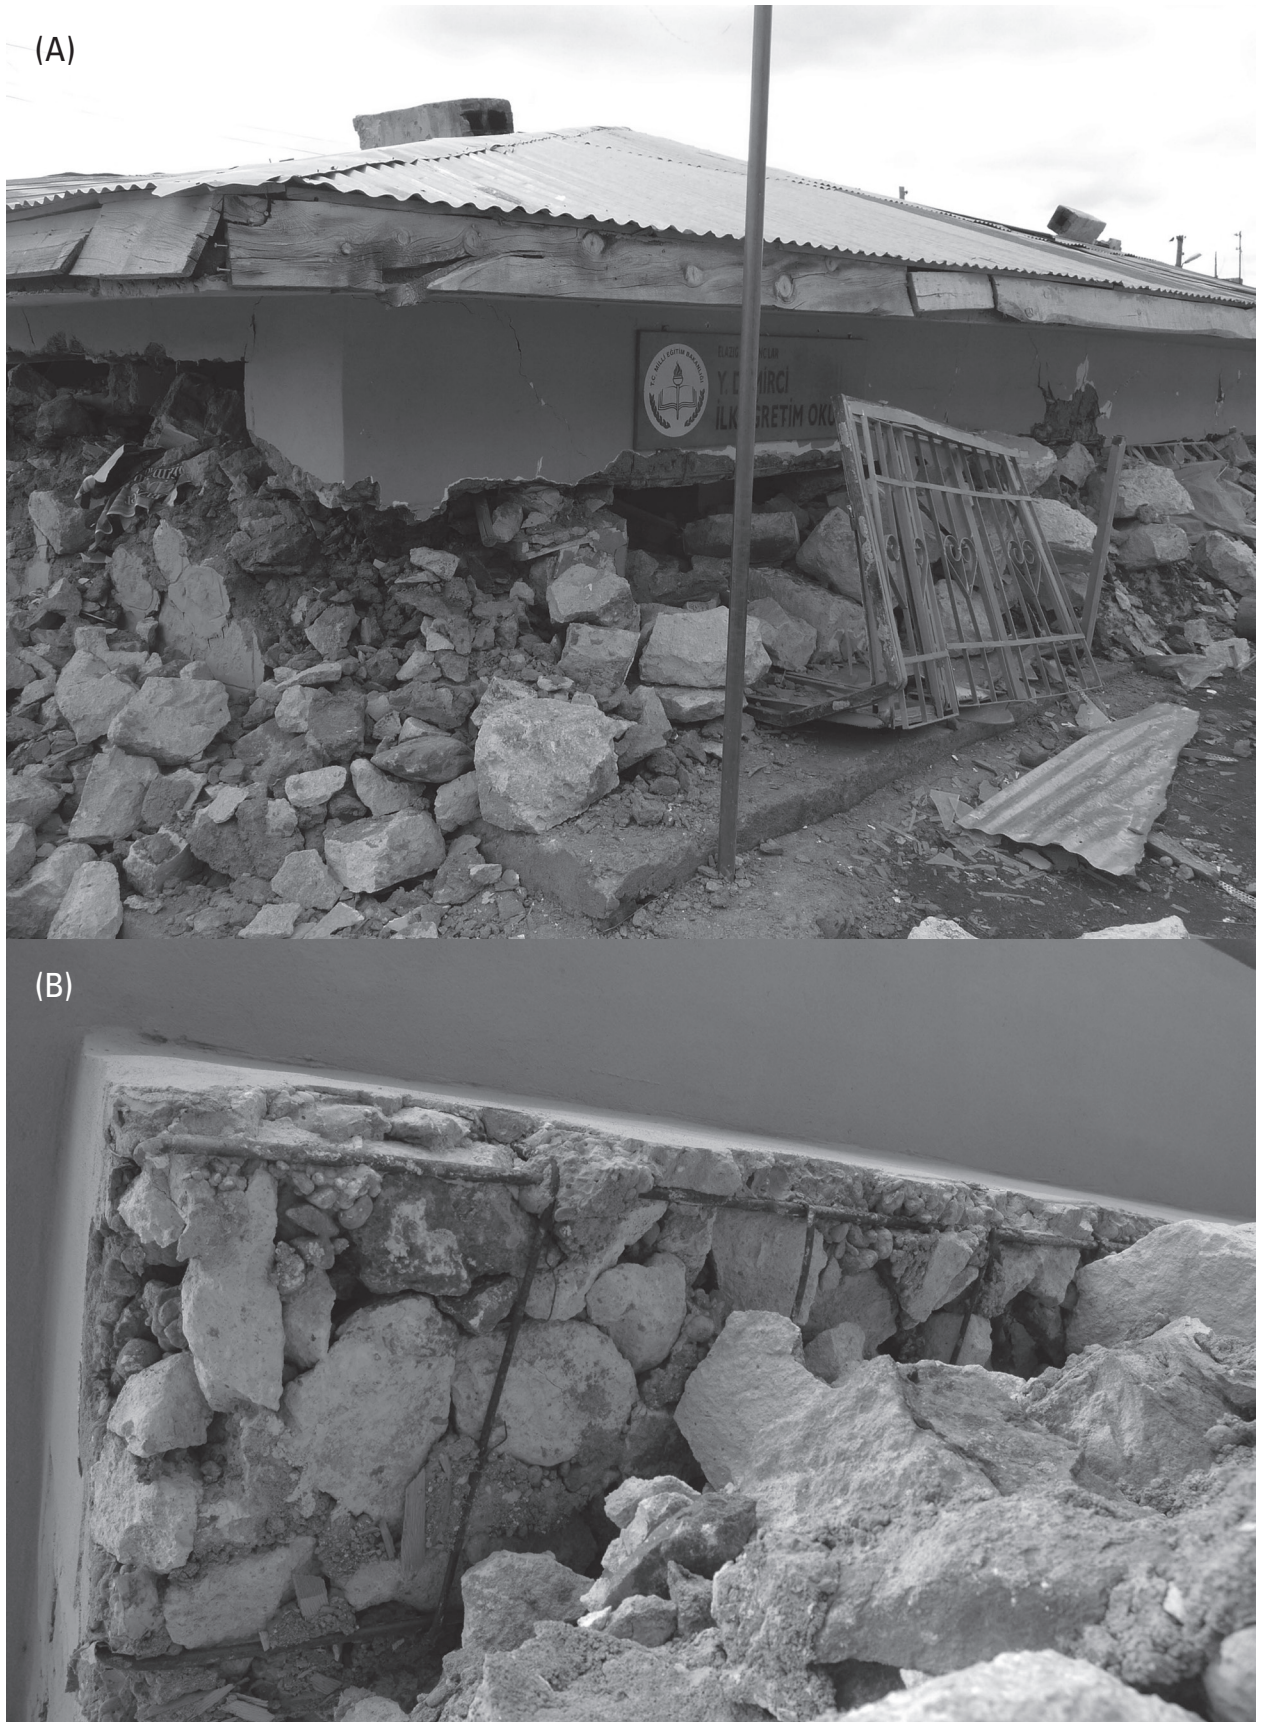
Primary school buildings in the affected villages were stone masonry buildings of Type I and II, and they experienced significant damage during the earthquake. The school building in Yukarı Demirci collapsed. A closer look at the collapsed school building revealed that there was a ring beam at the roof level of the building that was supposed to be made of reinforced concrete, but it was “reinforced stone,” *i.e.*, pieces of crushed stone inside a reinforcement cage with an inadequate amount of mortar to hold the pieces together and to fill the spaces (Figure 9). Primary school buildings in two other villages were also severely damaged. Hence, it was fortunate that the earthquake did not happen during daytime when the students would have been in their classrooms.

▲ **Figure 9.** Collapsed stone masonry school building in Yukarı Demirci village. A) Exterior view. B) Closer look at the reinforced stone ring beam at the roof level.

The engineering reconnaissance showed that despite important advances toward achievement of seismic safety elsewhere in the country, rural areas with low economic status still lack adequate life safety. Of particular concern is the poor performance of school buildings, the most widely used facilities. An inspection program must be immediately undertaken for school buildings similar to those that were damaged beyond repair. ☒

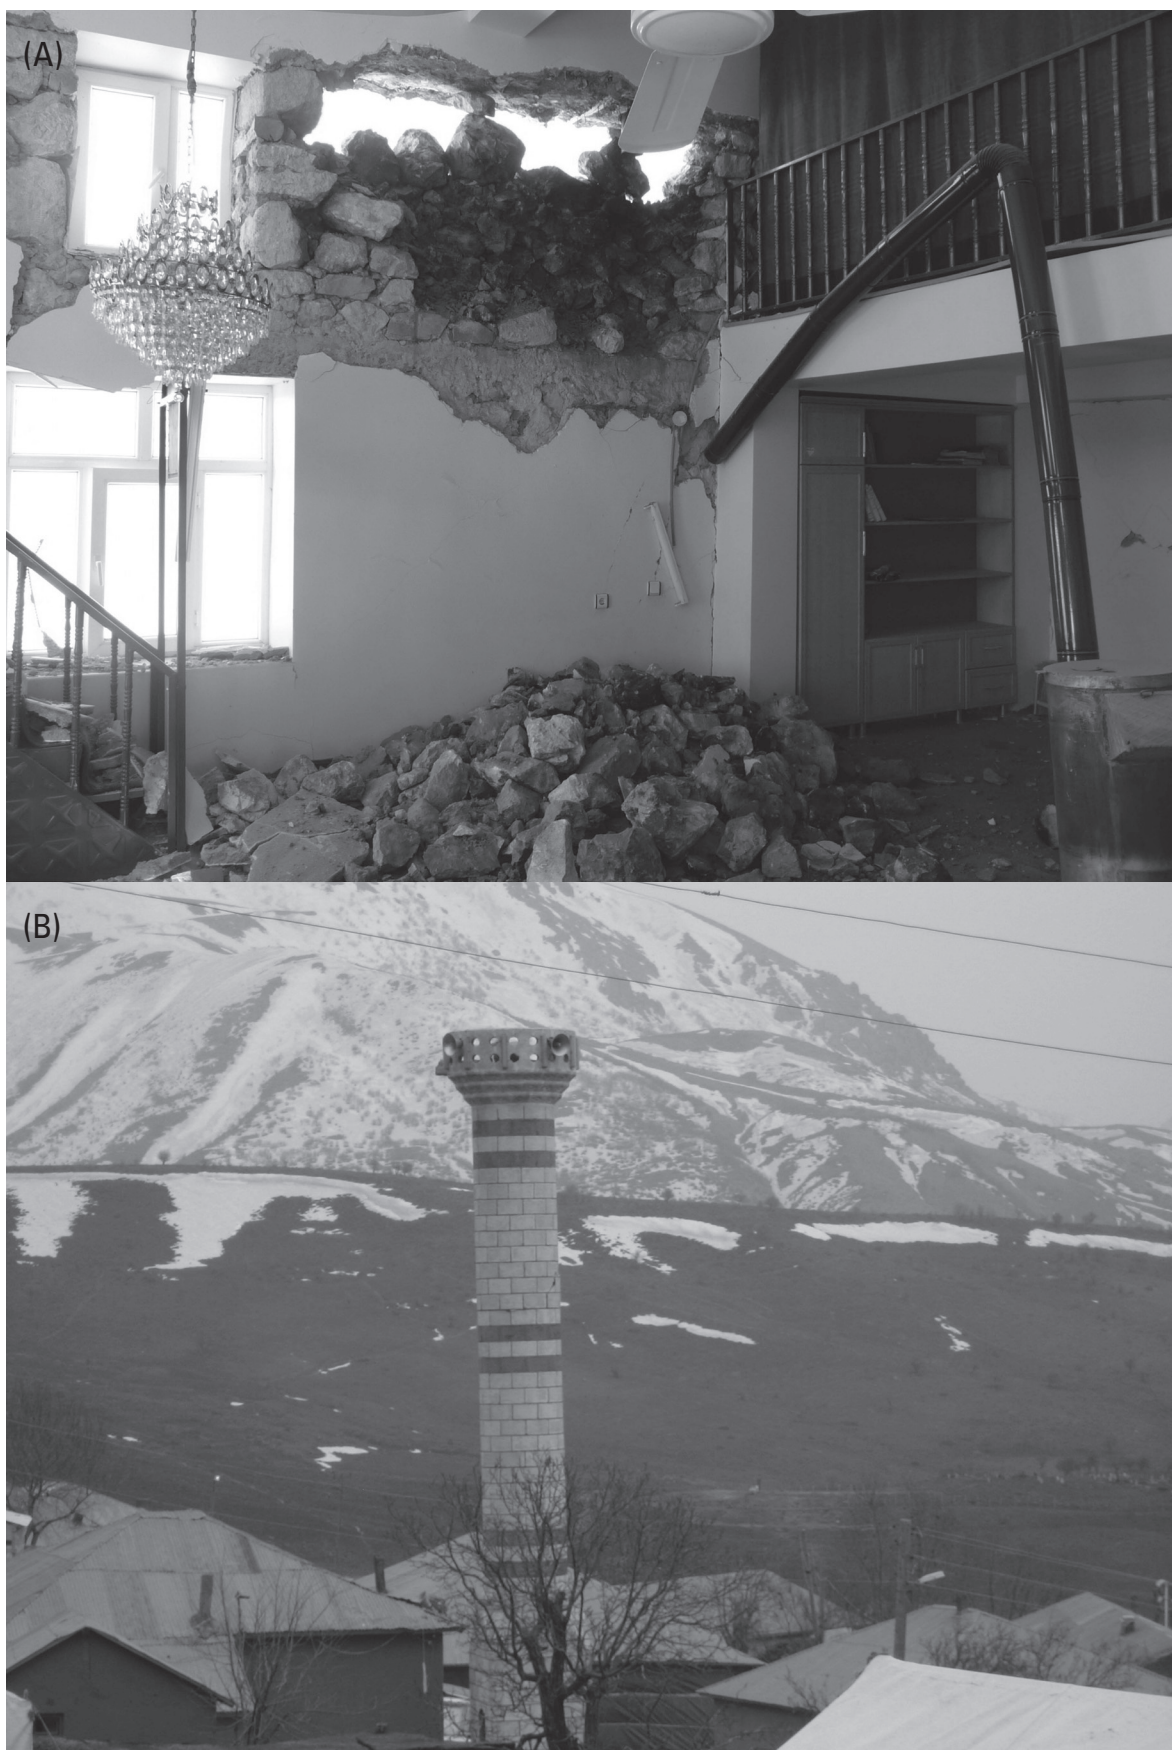
Mosques and minarets were also damaged in the villages during the earthquake. Figure 10A shows the interior view of the mosque in Yukarı Kanatlı village. It was a Type II stone masonry building with out-of-plane damage to its exterior walls. Minarets in three of the villages were also destroyed (Figure 10B).

▲ **Figure 10.** A) Interior view of the damaged mosque in Yukarı Kanatlı village. B) Damaged minaret in Yukarı Demirci village.

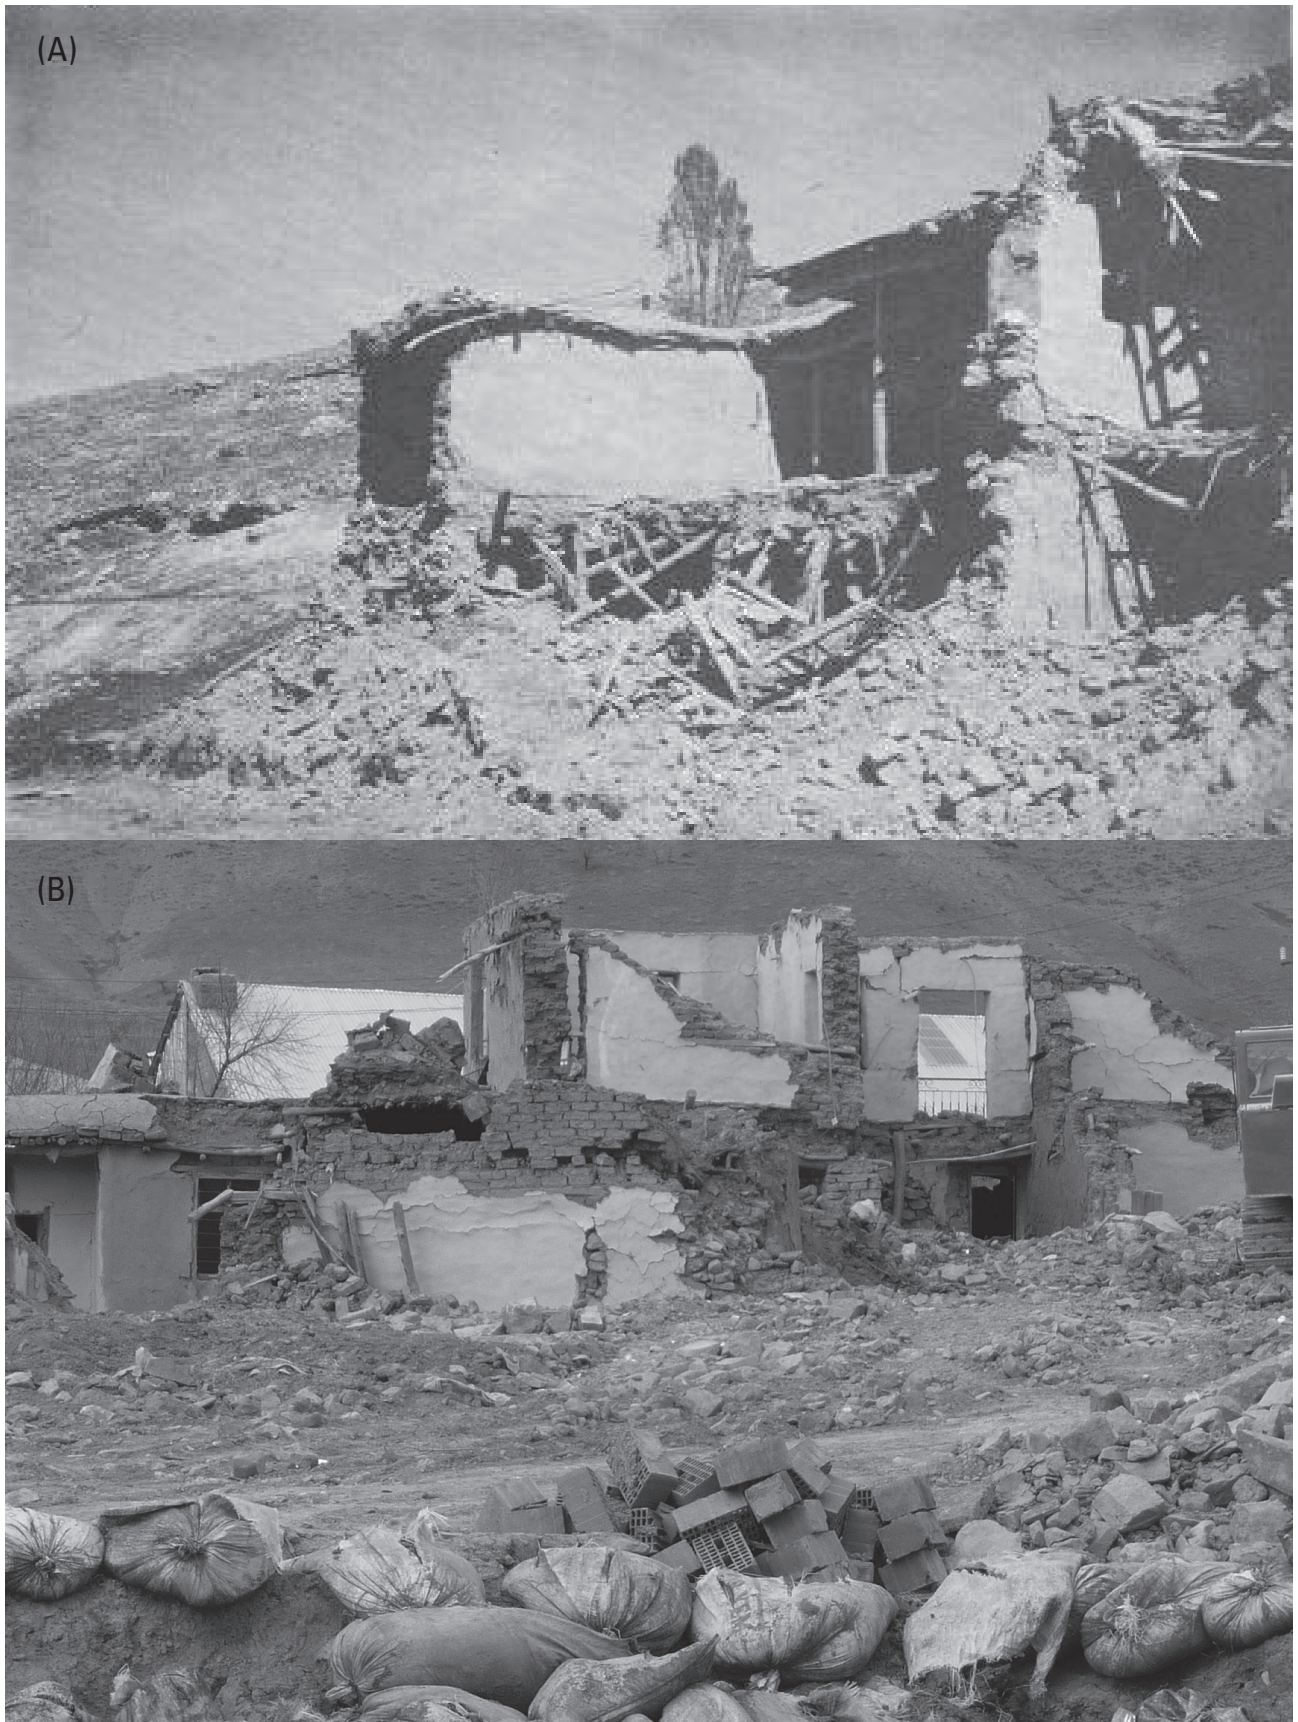
A final comment on building practices is illustrated vividly in Figure 11, which shows damage to the type of rural buildings that have been described in this report. With little differences in the way dwellings are built (usually by their owners) between 1977 and 2010, there is also little difference in their seismic capacities. Minor improvement in details would have served to avoid collapses and the resulting losses of life.

▲ **Figure 11.** Photos taken from collapsed rural masonry buildings. A) During the Elazığ Palu earthquake in 1977. B) Elazığ Kovancılar earthquake in 2010.
